Finnish Yacht Surveyor Association MARINE SURVEY REPORT

Motor yacht, Ferretti 620, hull no XX, 2013. Reg.nr. XXXXXX.

Survey prior to possible purchase of the yacht.

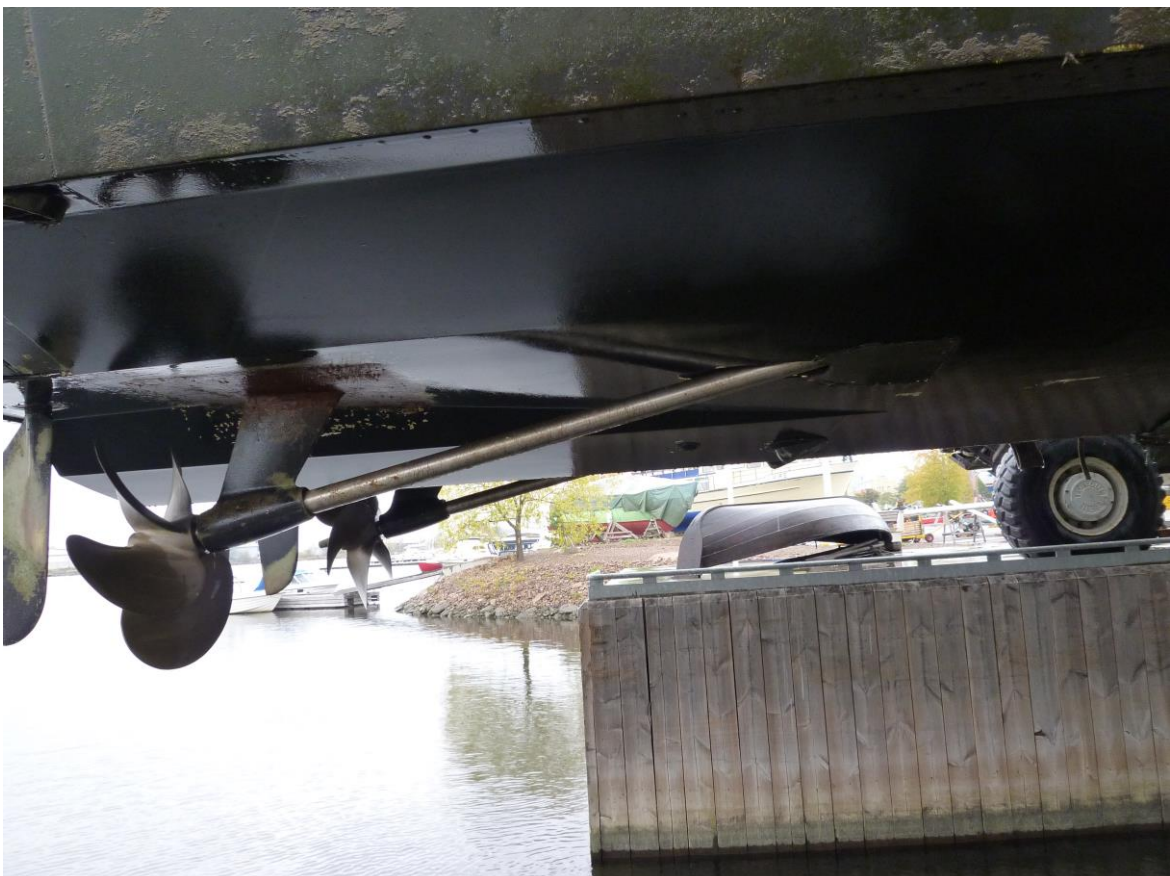
On SB side, approximately under the SB main engine is two marks in the hull where something has hit the boat.

- The hull damage under the SB engine must be repaired, together with the oil and water leakage. If the engine must be removed it can be an expensive repair.
- The BB propeller must be repaired or replaced.
- The BB propeller shaft support must be checked and/or repaired.
- Both propeller shafts should be measured that they are straight and in line. If that is not the case, they should be repaired or replaced.

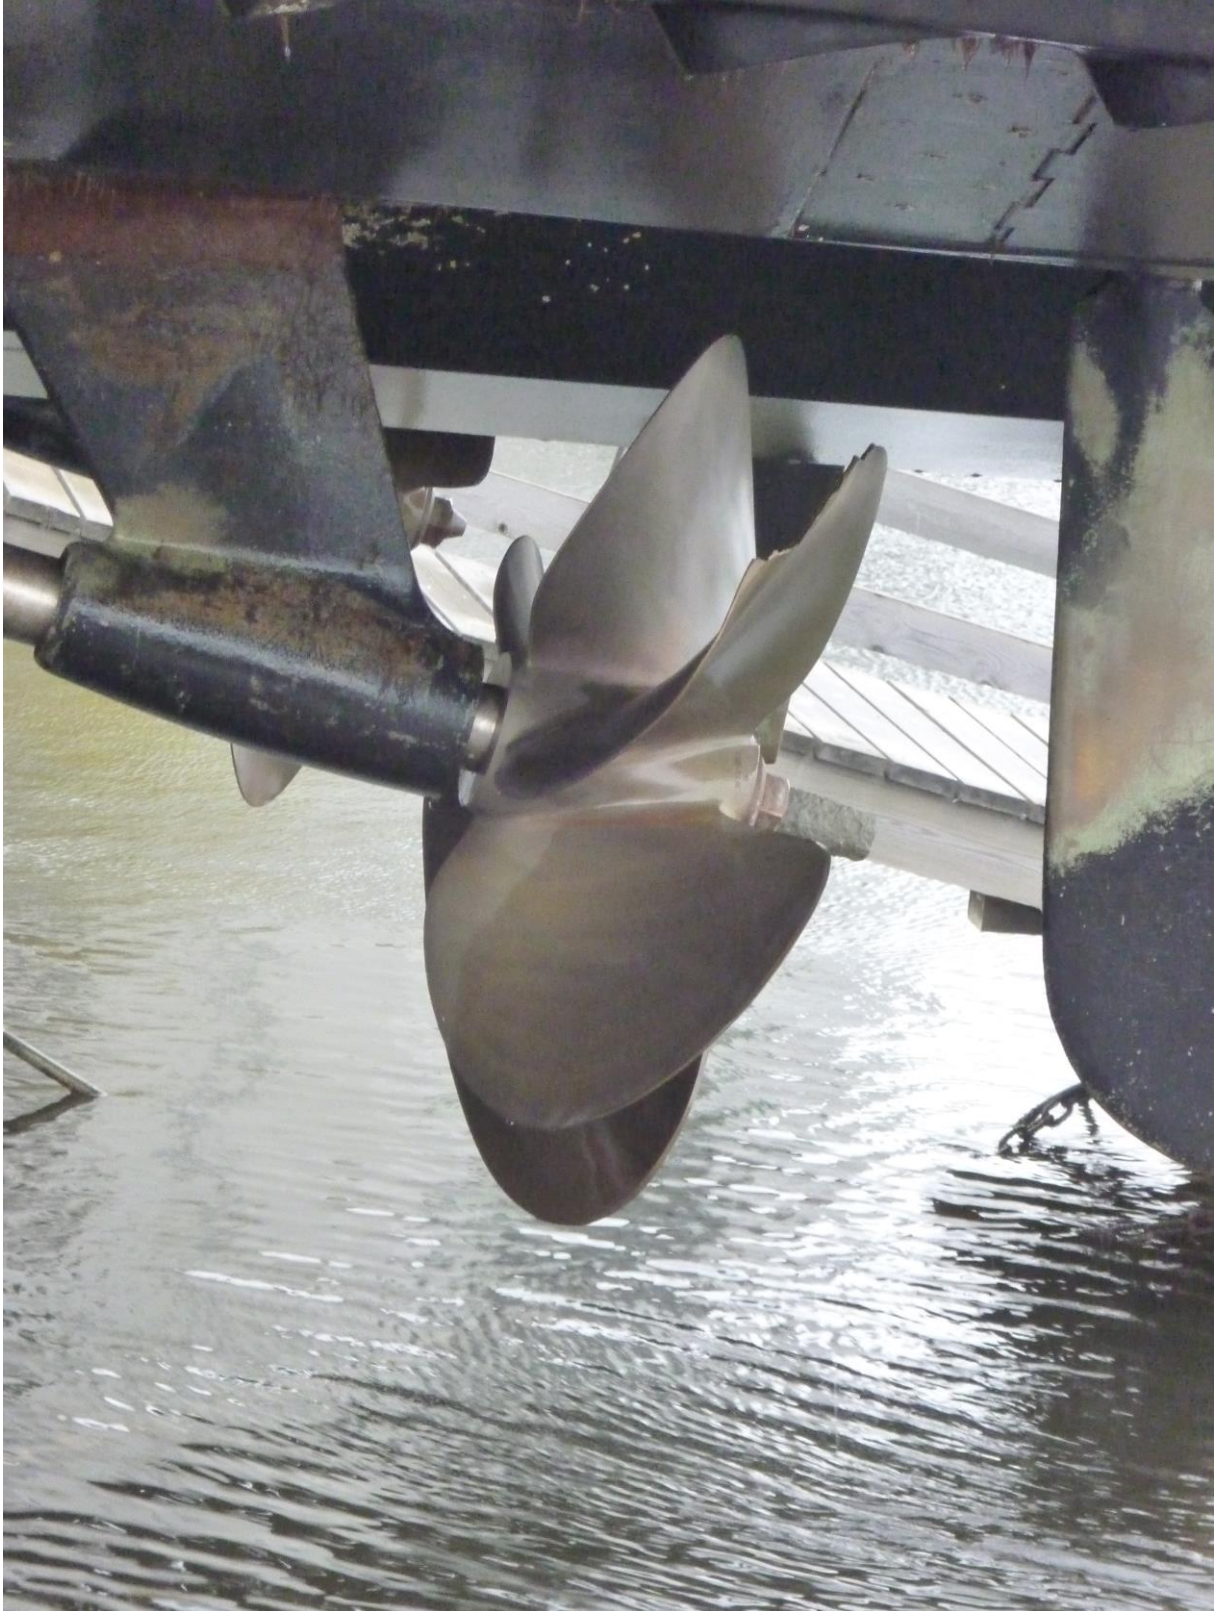
-The BB propeller is damaged. One blade is missing a part of its tip, and the blade is bent.

-The sea trial went well, and everything was normal, except for a slight vibration at full speed. At cruising speed no vibrations could be felt. The vibration may be caused by the damaged propeller and/or a slightly bent, or out of line, propeller shaft.

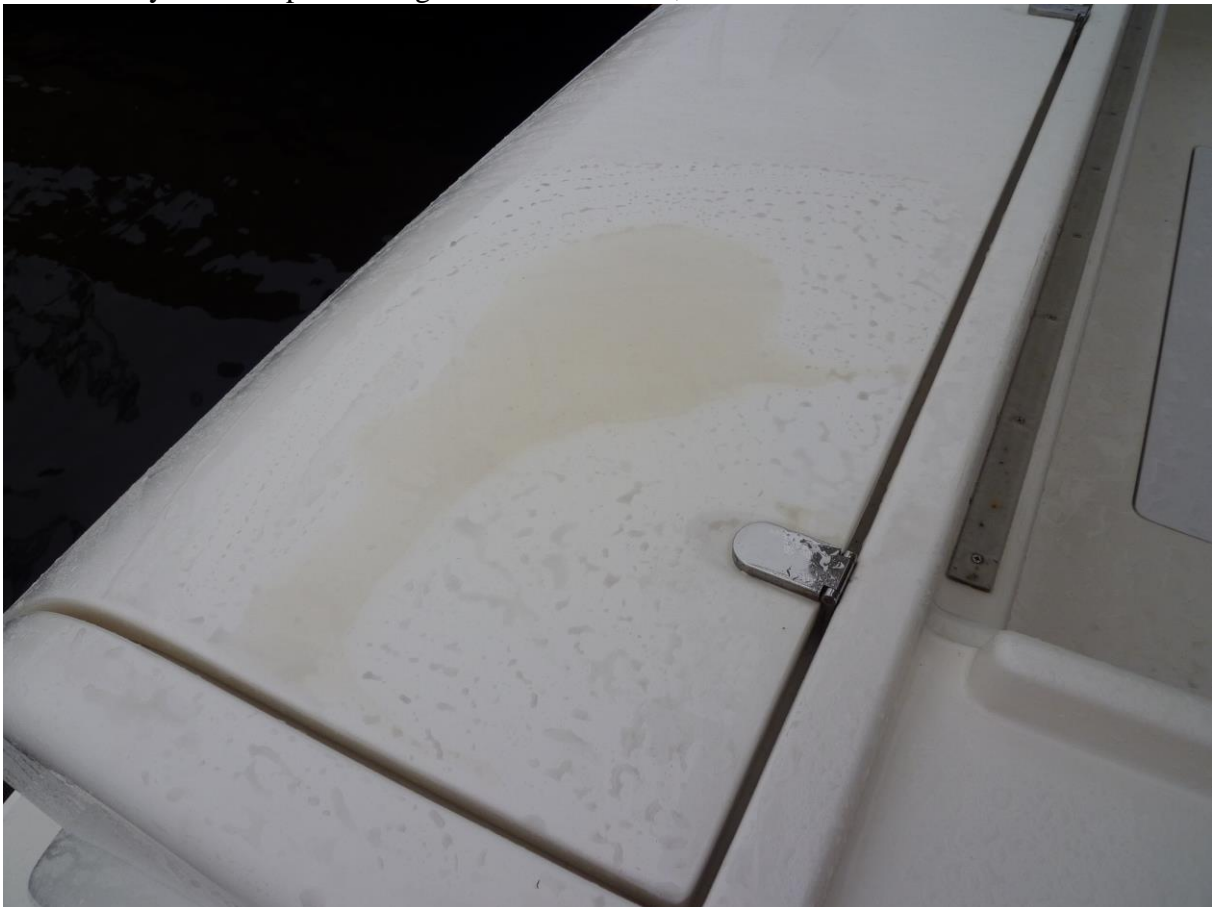
-There is a yellowed spot in the gelcoat on the cover, over the aft crane.

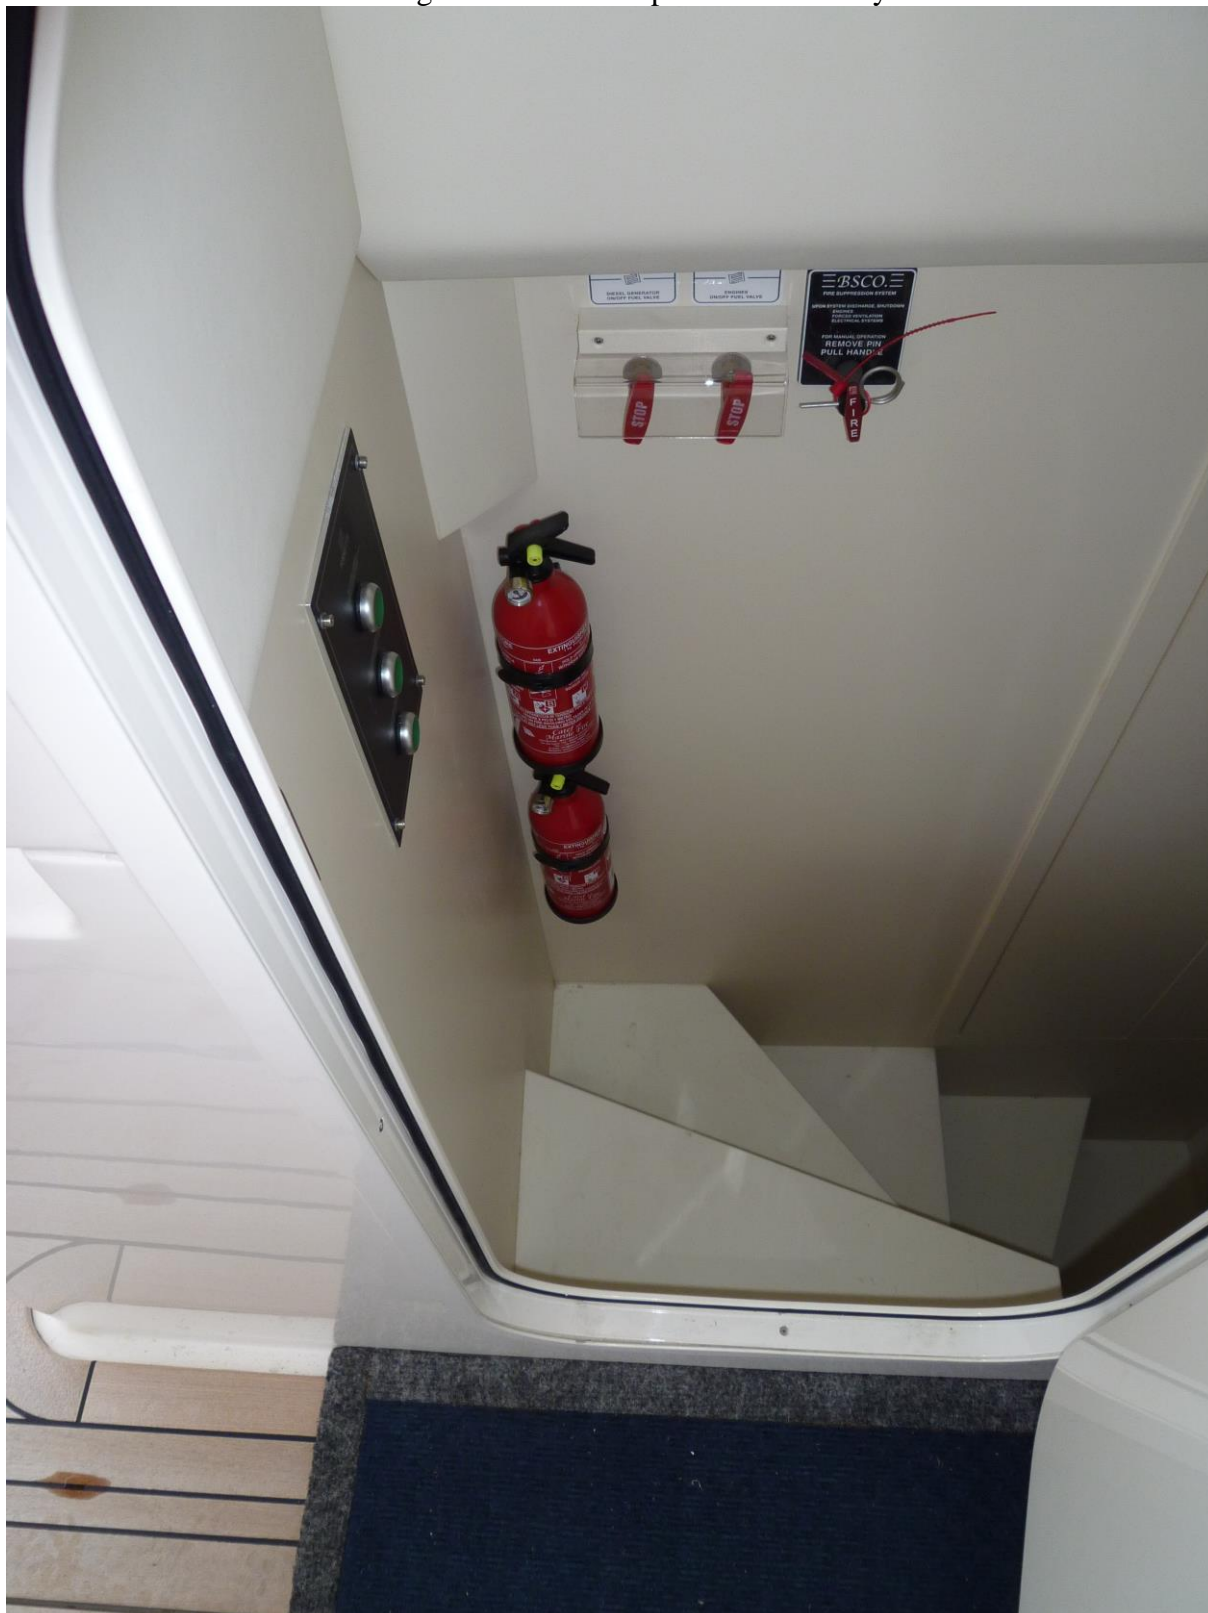
-The door to the crew cabin is tight and does not open or close easily.

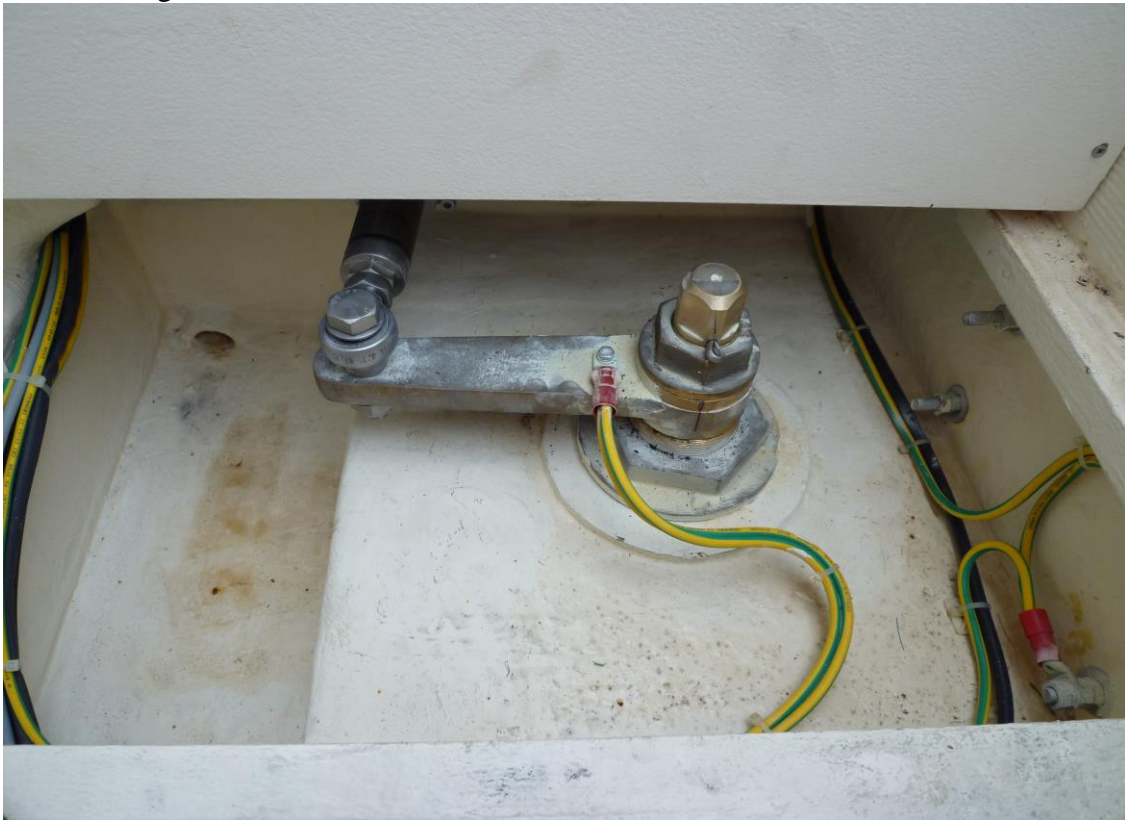
- The engines, generator, pumps, etc. worked well, but there was a small oil leak from BB engine that the service crew promised to fix.
- The steering was OK.

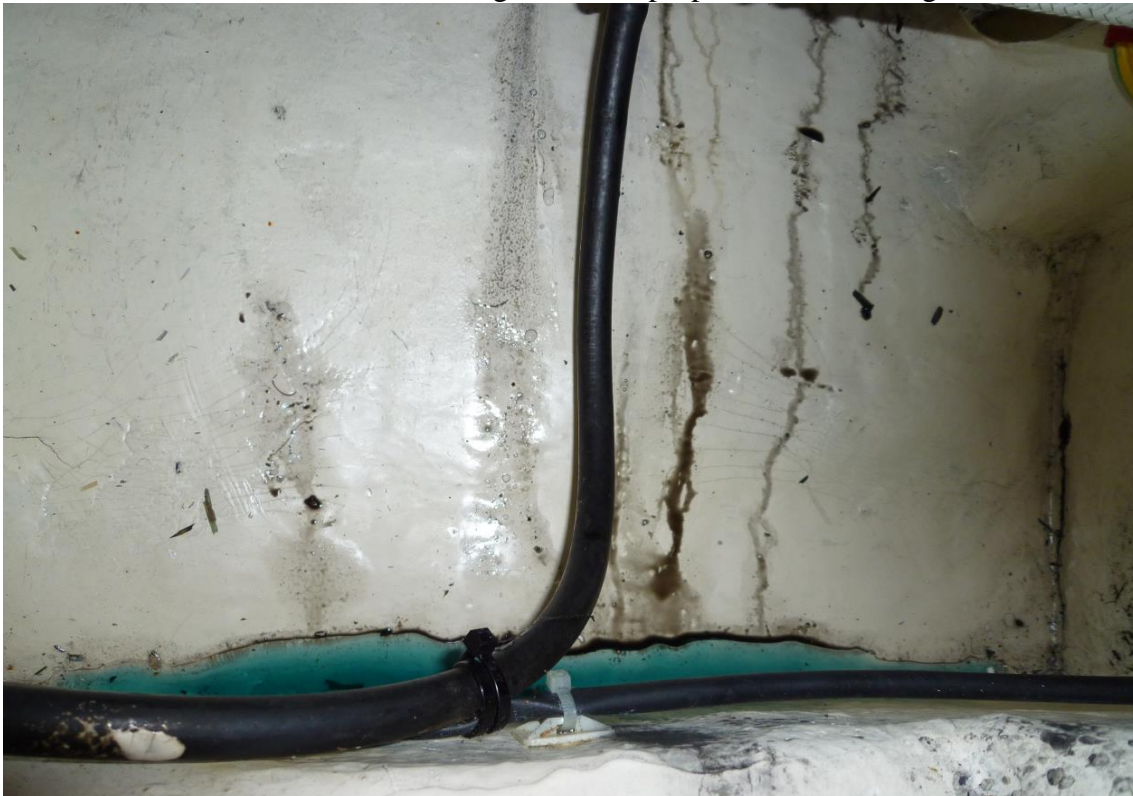
- Also there was an oil and water leakage from SB propeller shaft bearing.

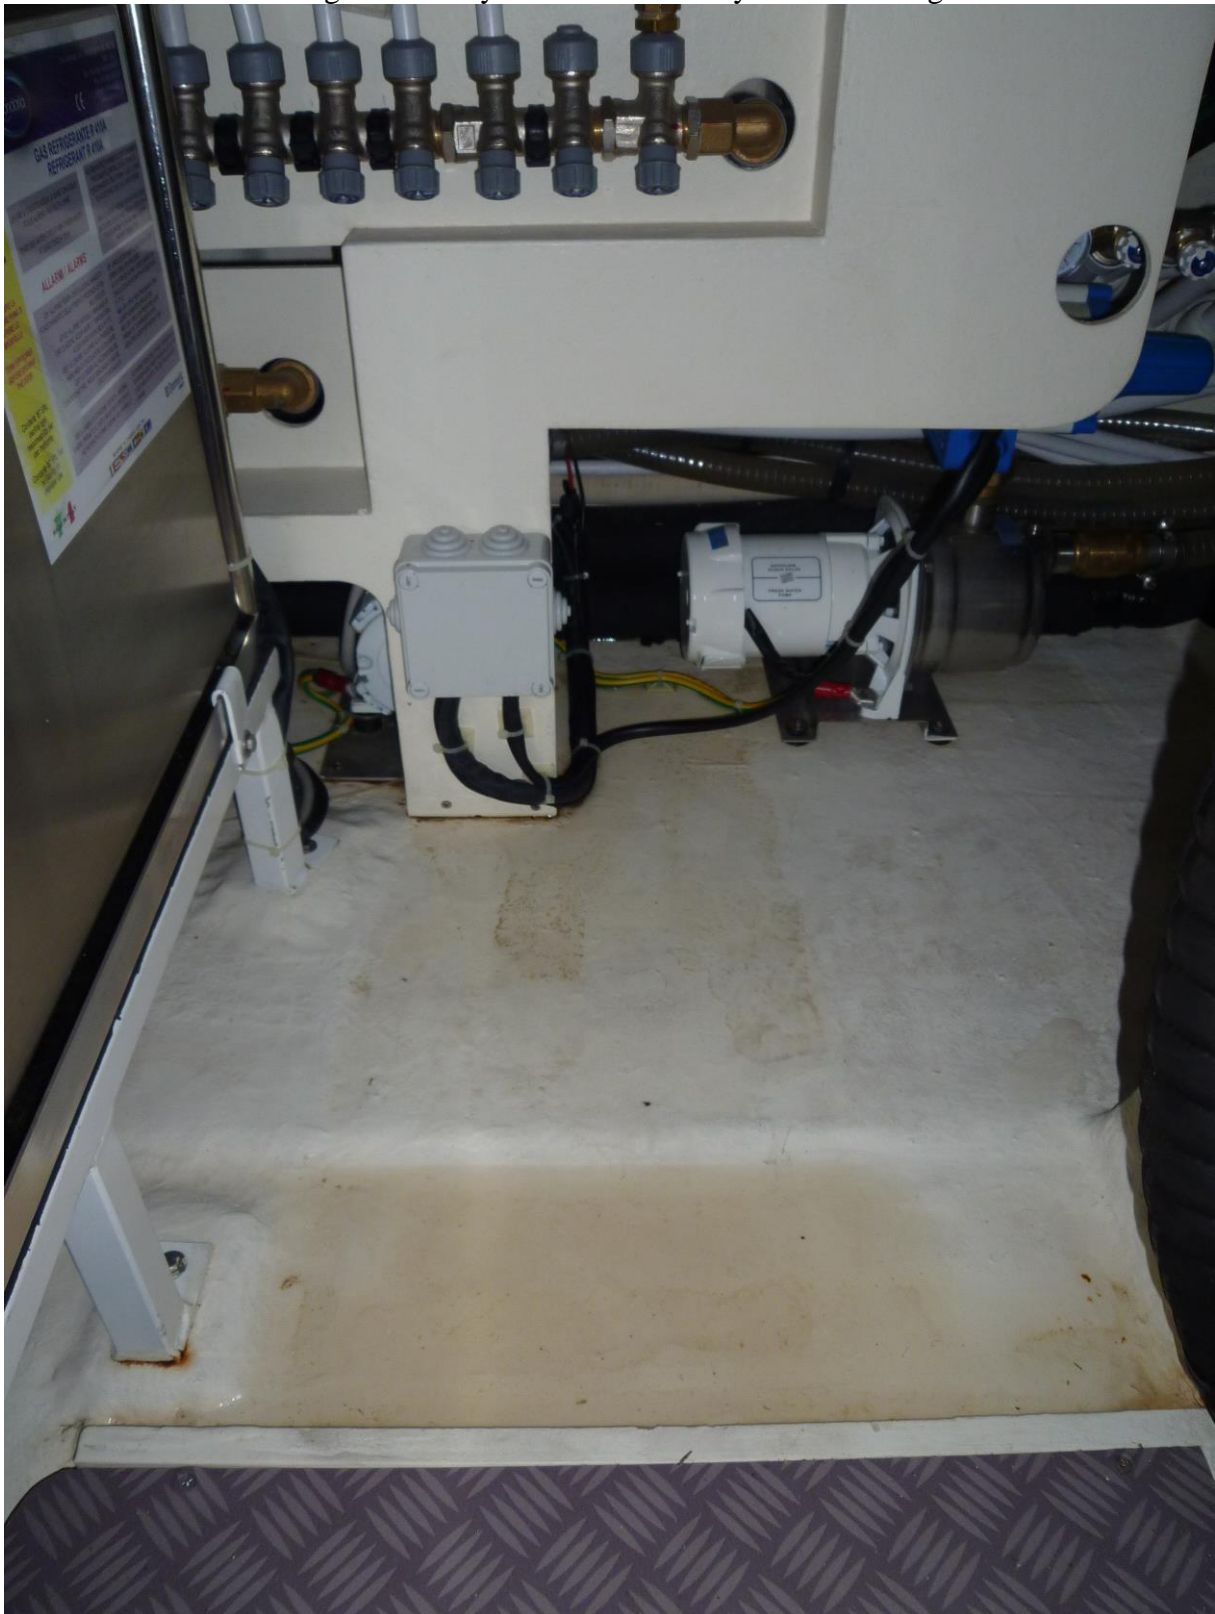
-There was a water leakage from the yachts fresh water system in the engine room.

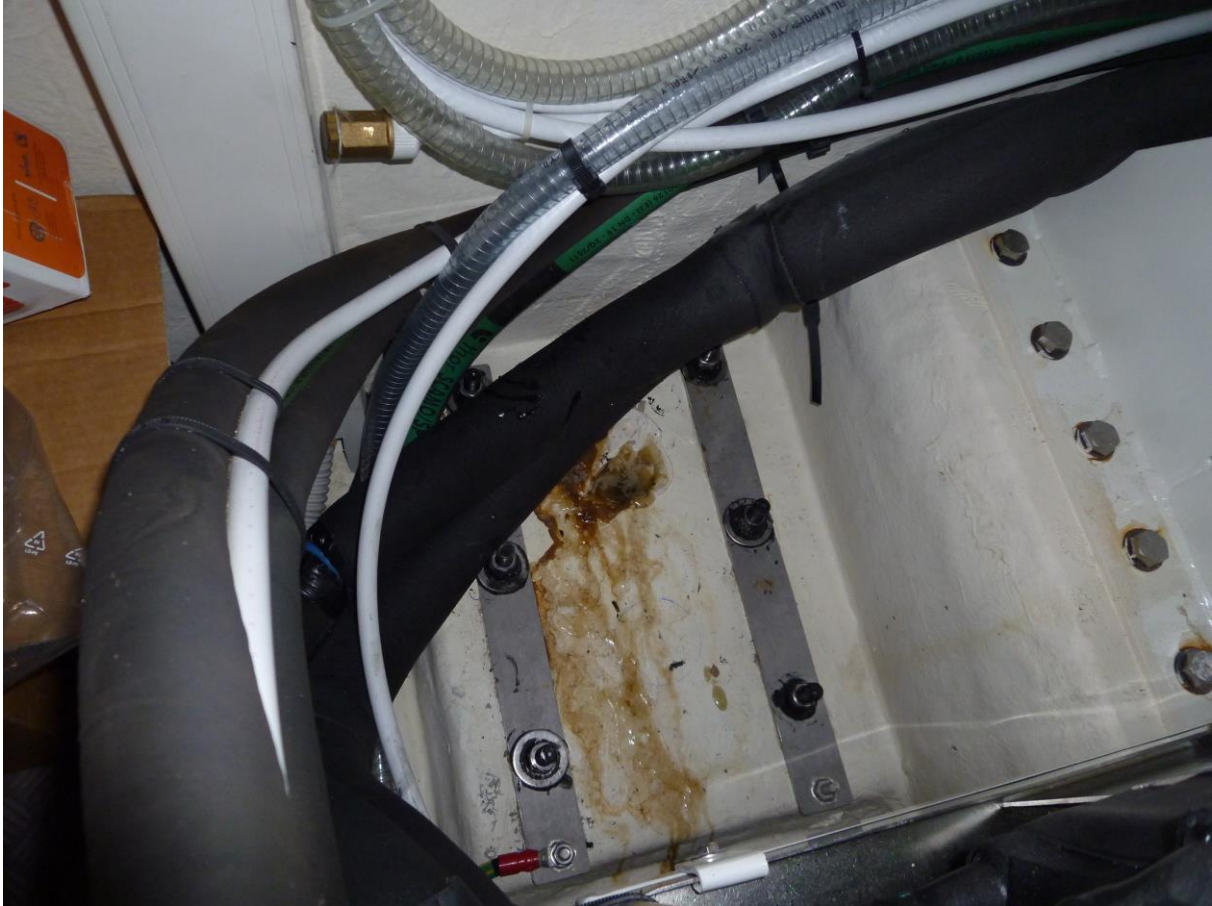
-There was something wrong with BB propeller shaft support compared to SB one, and a lot of grease on top of the BB one, inside the engine room.

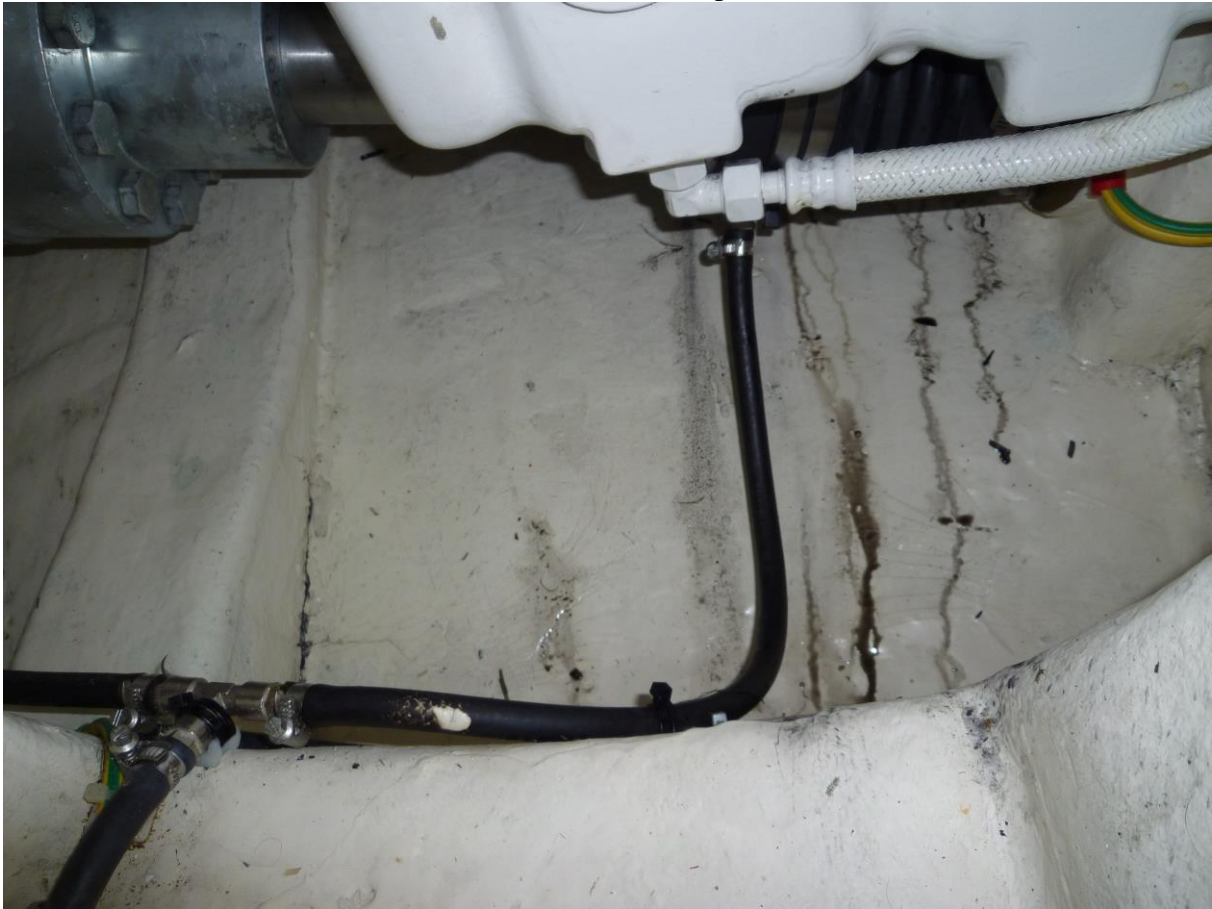
-The bottom, and the bottom frames are damaged under the SB engine. The damage seen inside, is probably connected with the damage visible on the outside. You can see cracks in the frame corners, and also on the bottom panel in between.
