Finnish Yacht Surveyor Association MARINE SURVEY REPORT

Motor yacht, Ferretti 620, hull no XX, 2013. Reg.nr. XXXXXX.

Survey prior to possible purchase of the yacht.

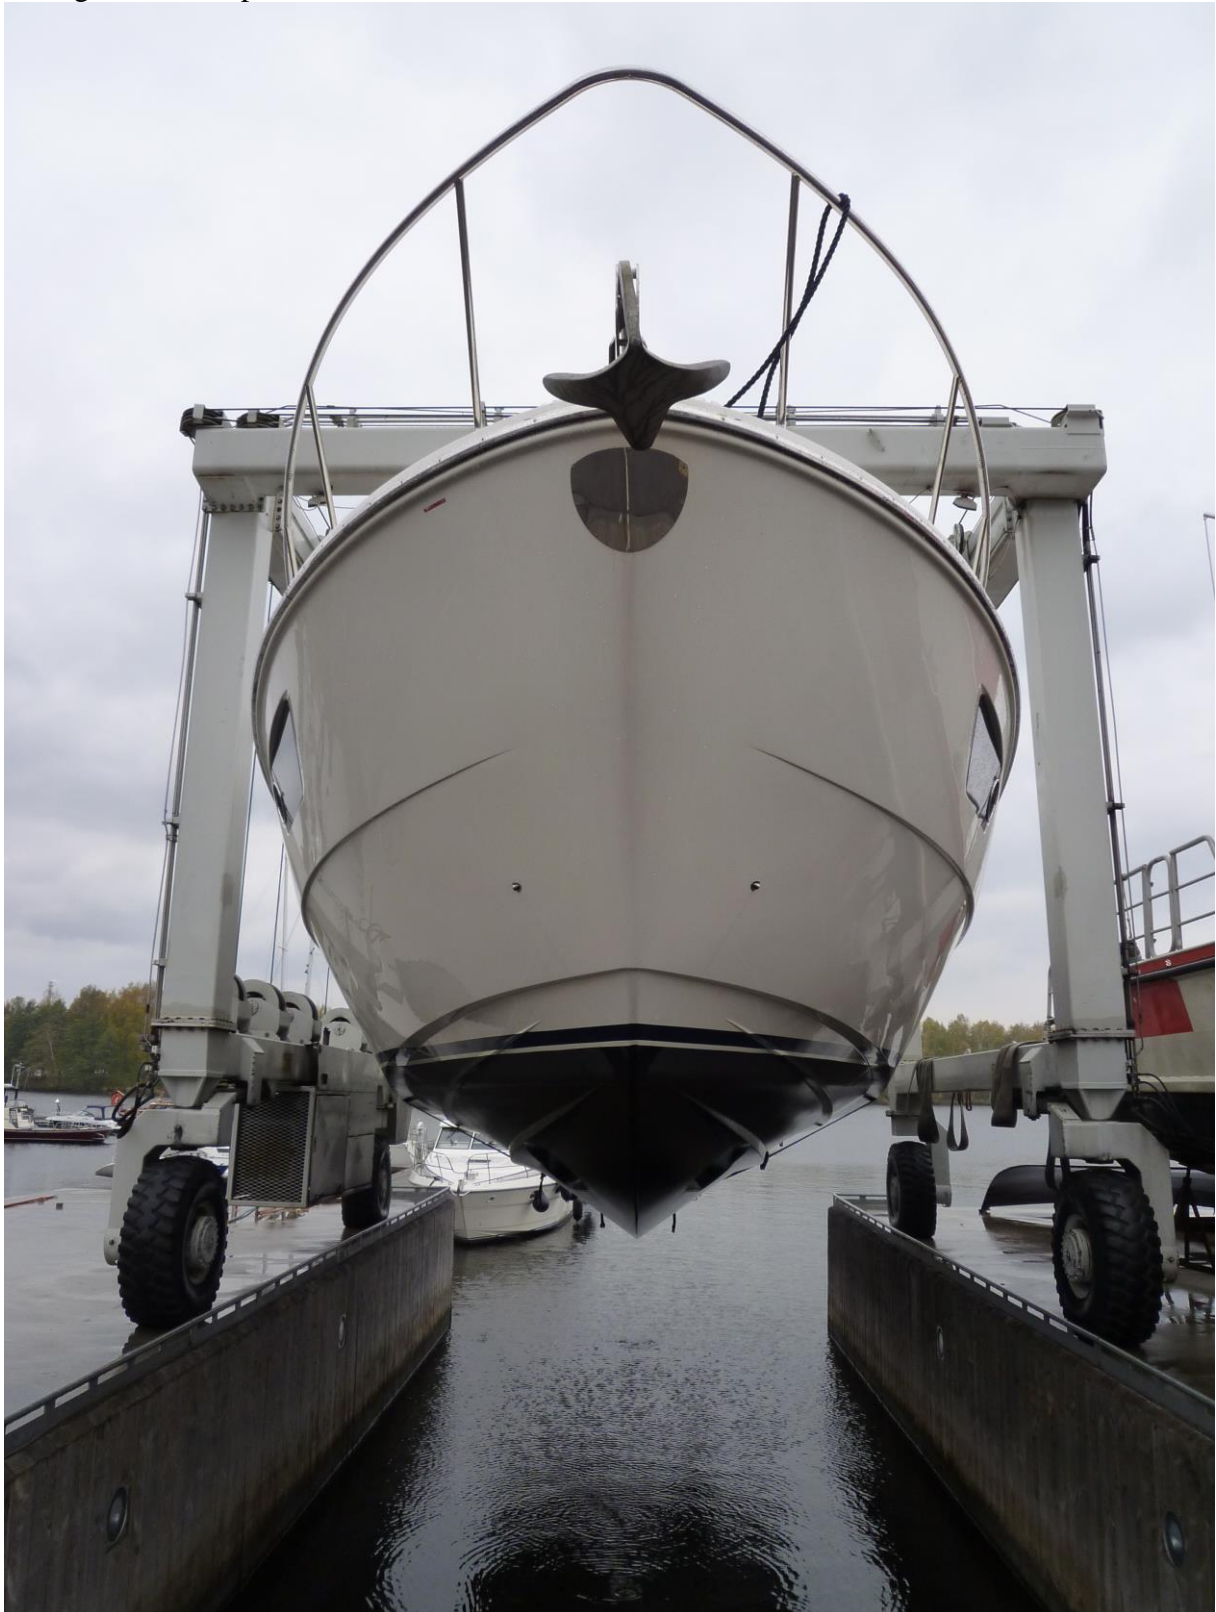
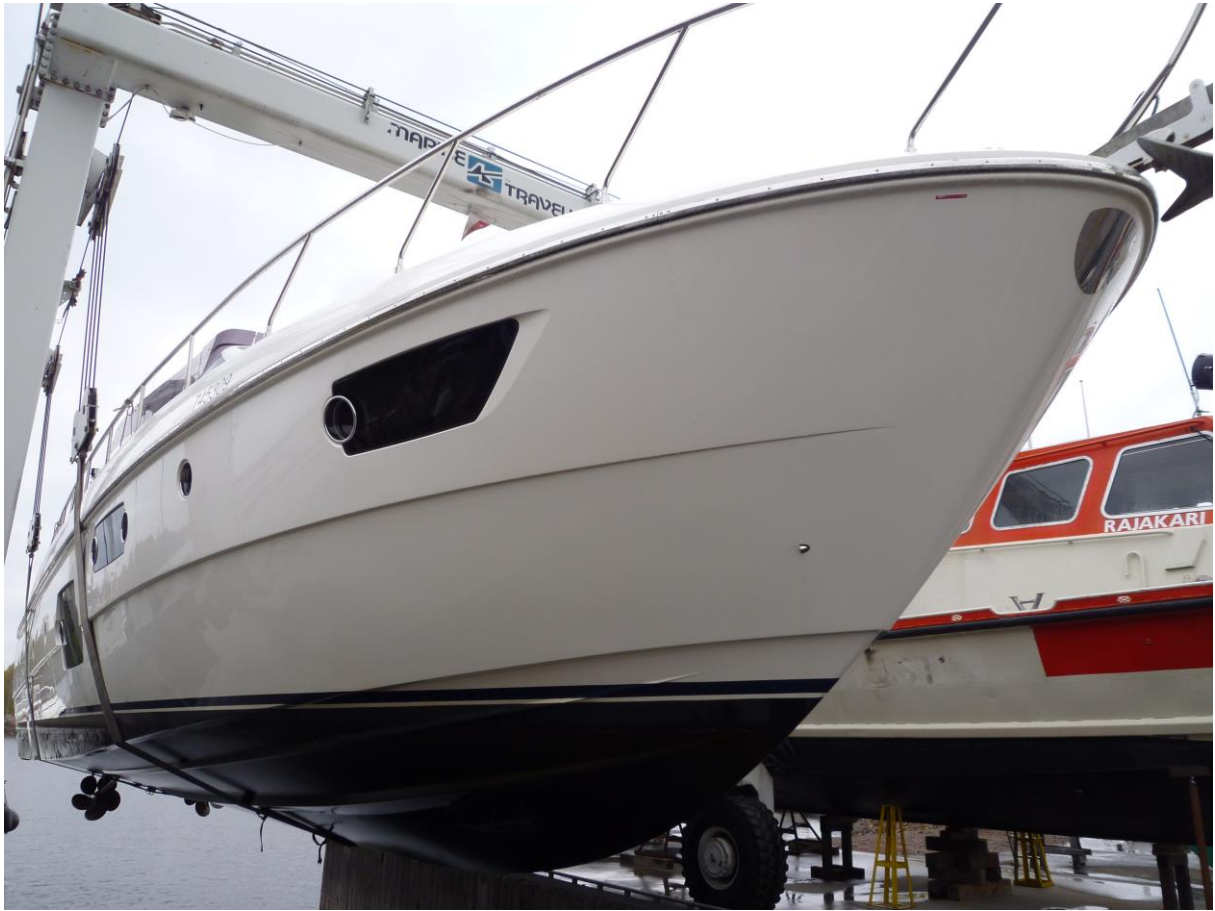
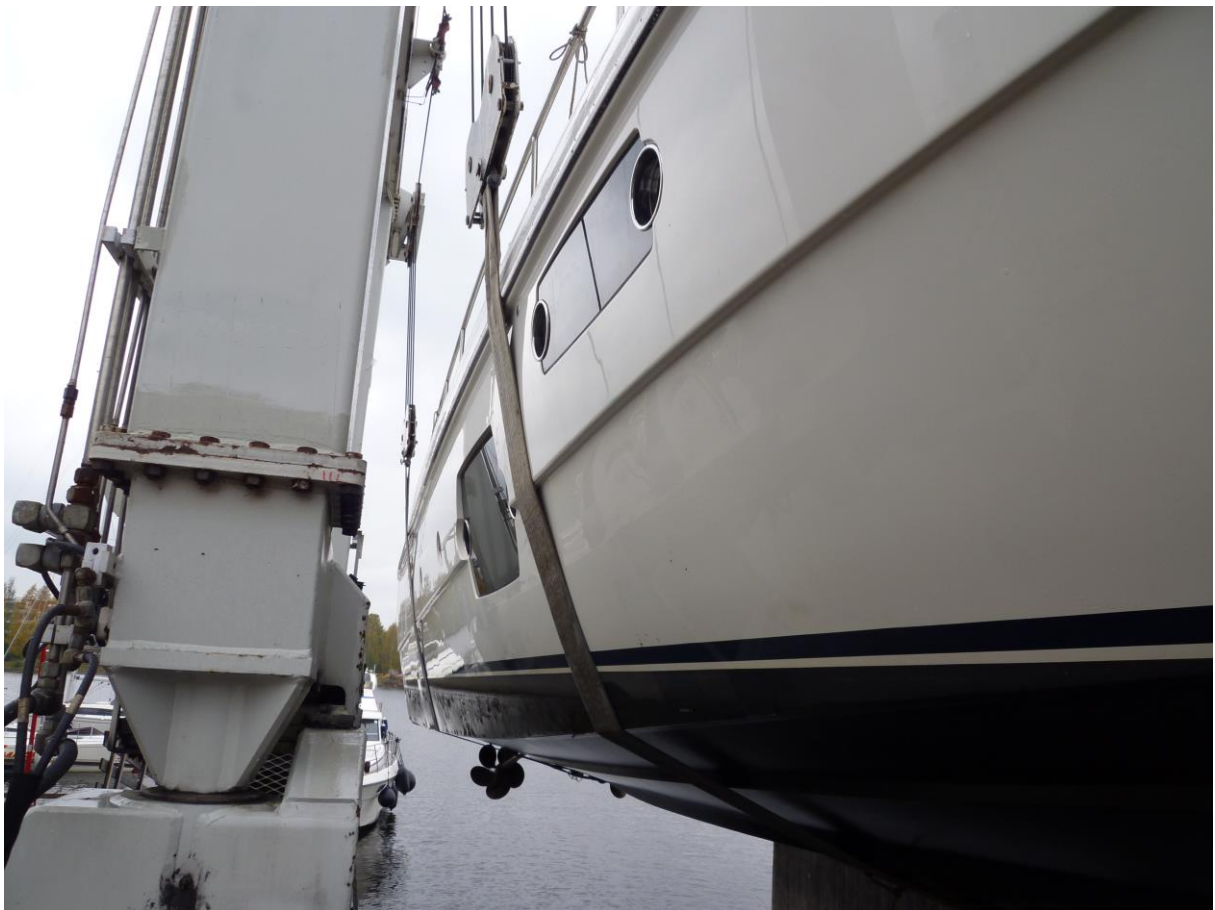
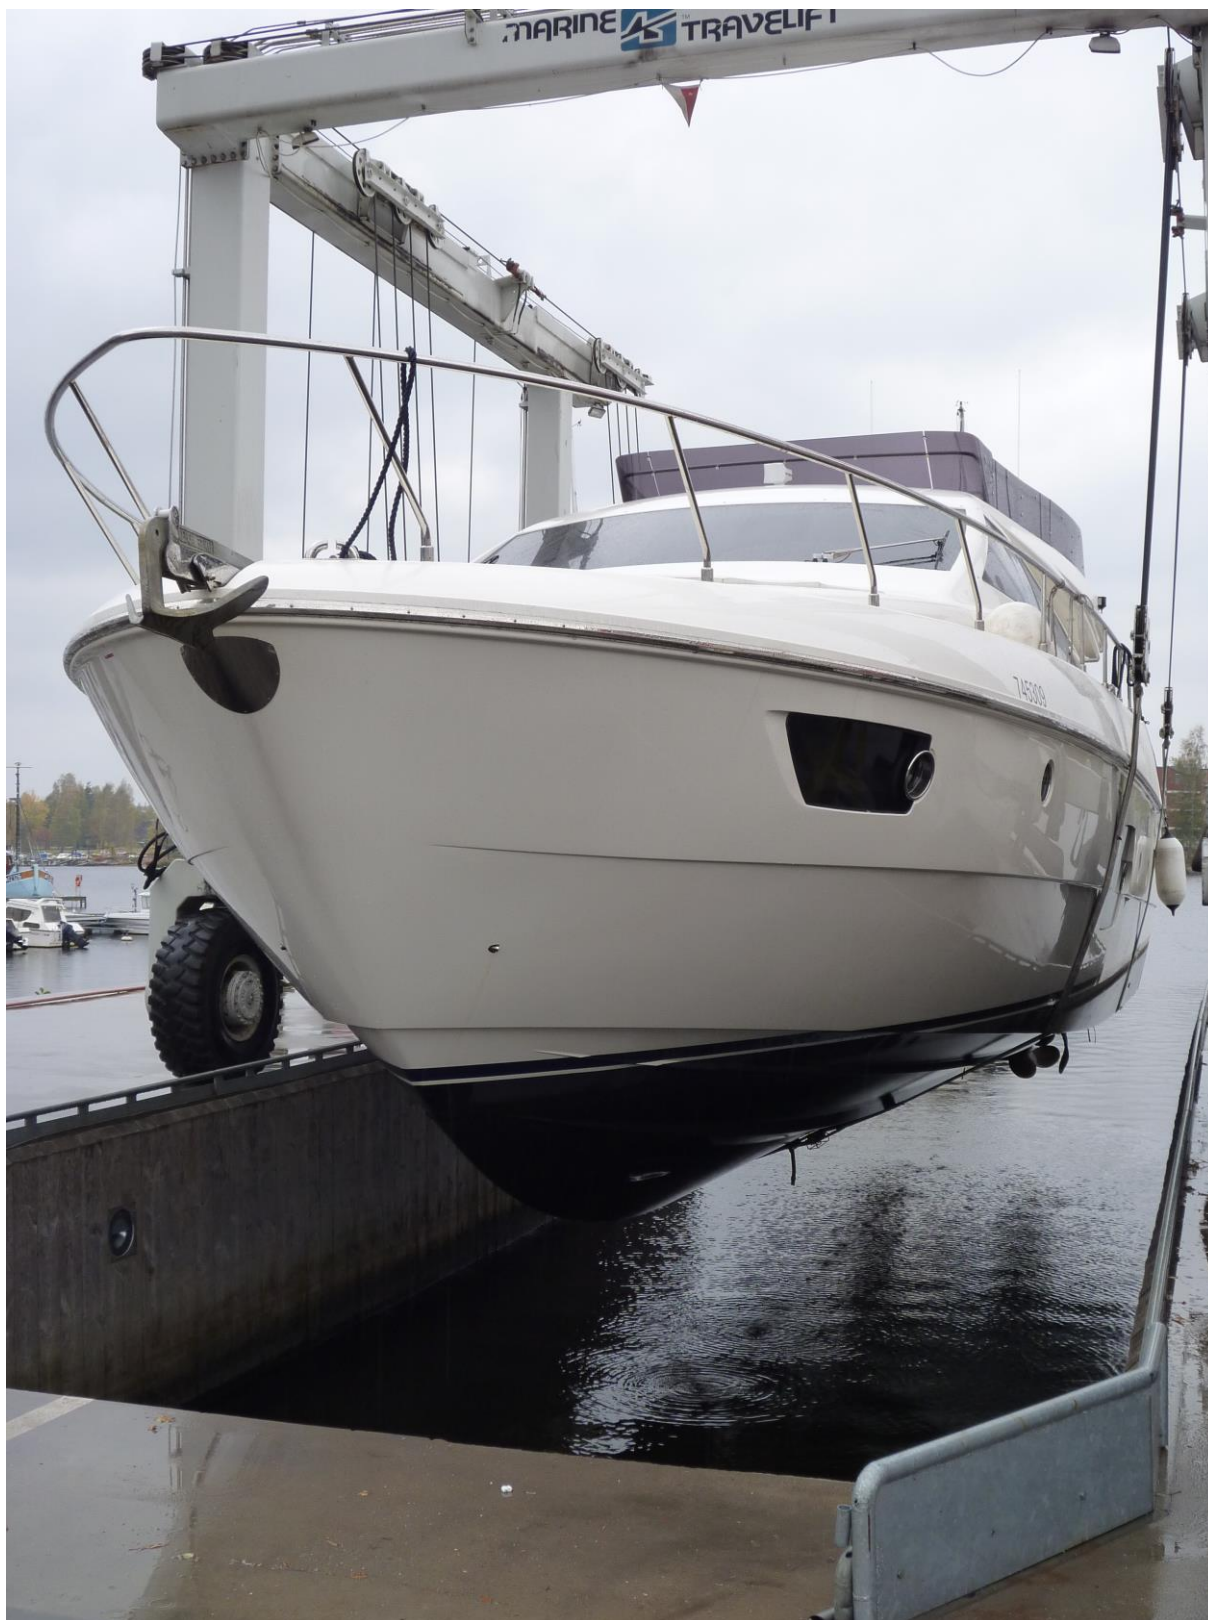
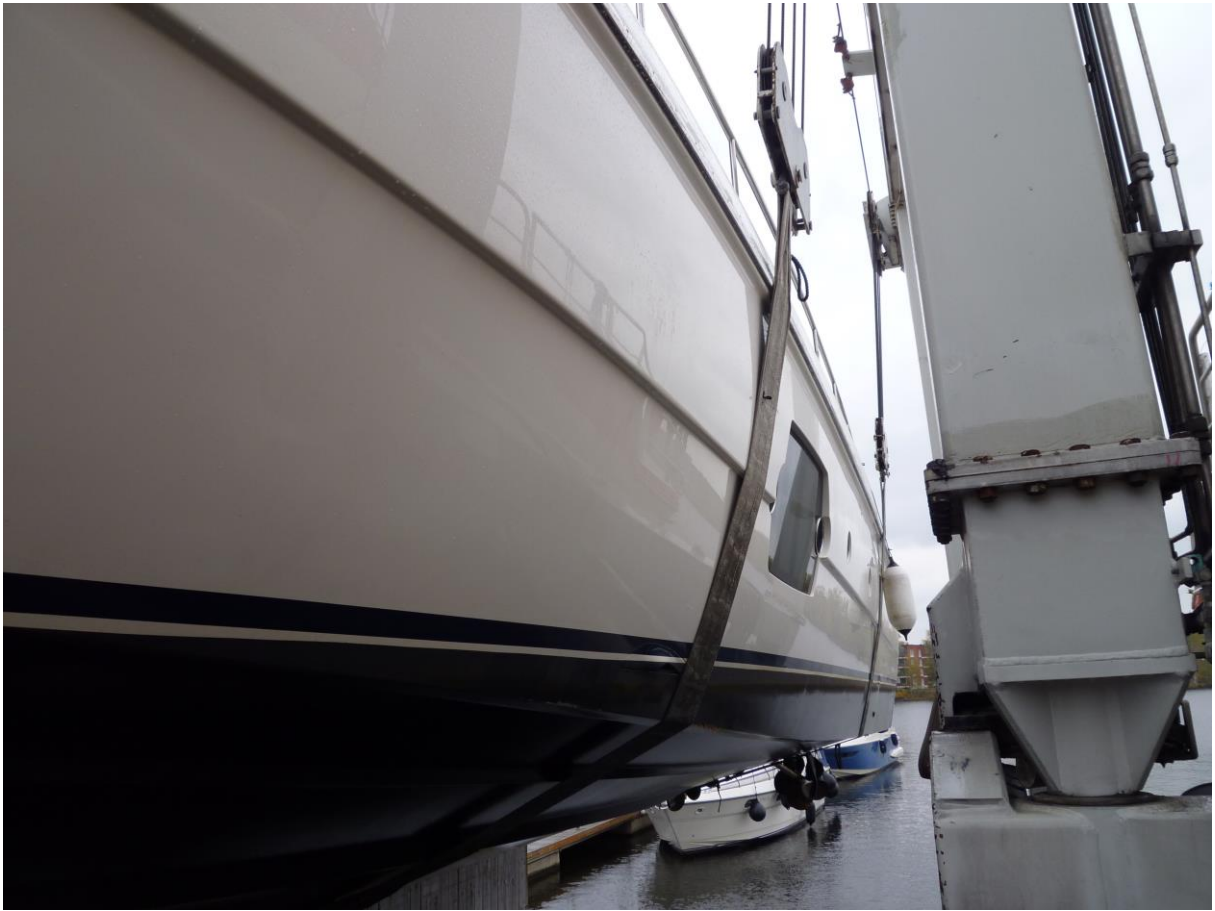
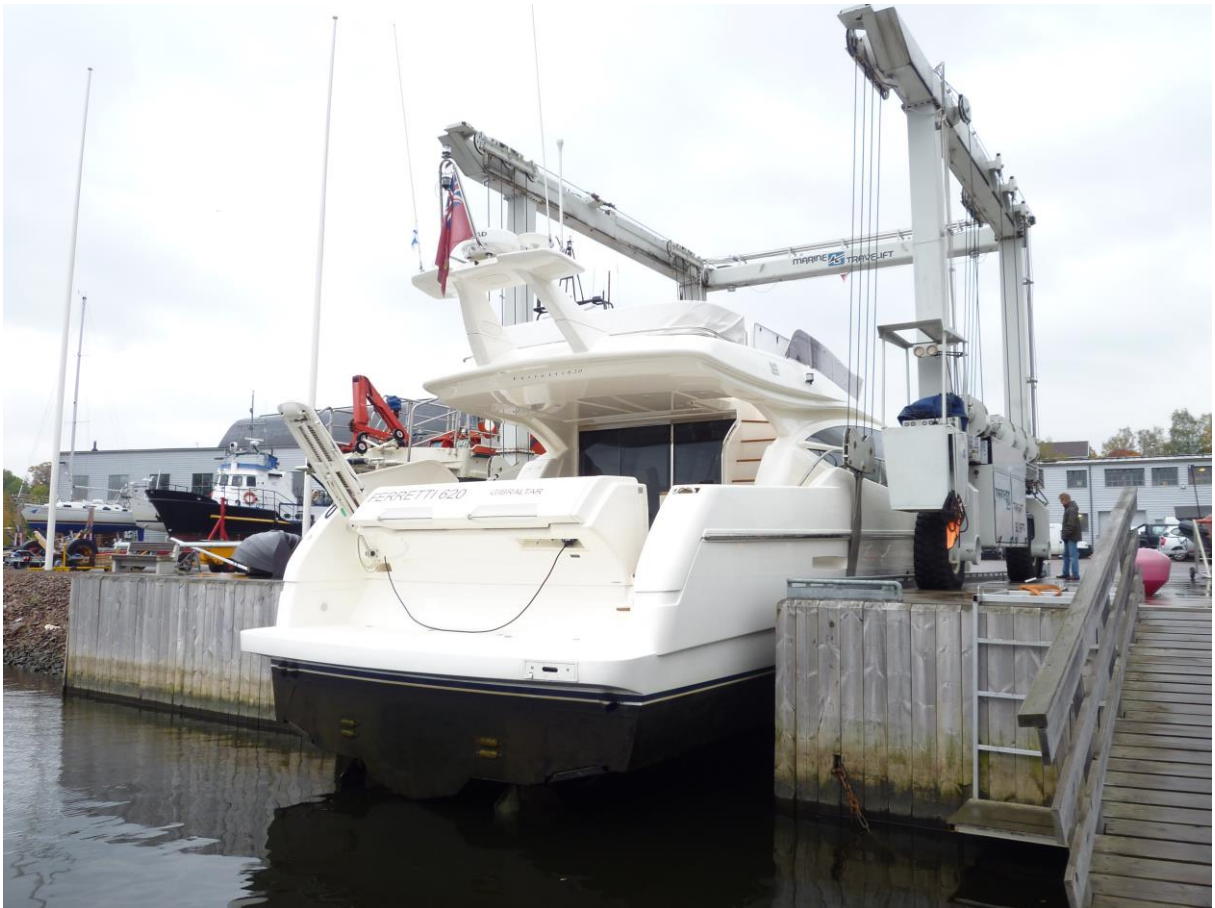
-The outside of the hull is in good condition. Neither in the bow, sides or stern could any damages, or old repairs, be found.

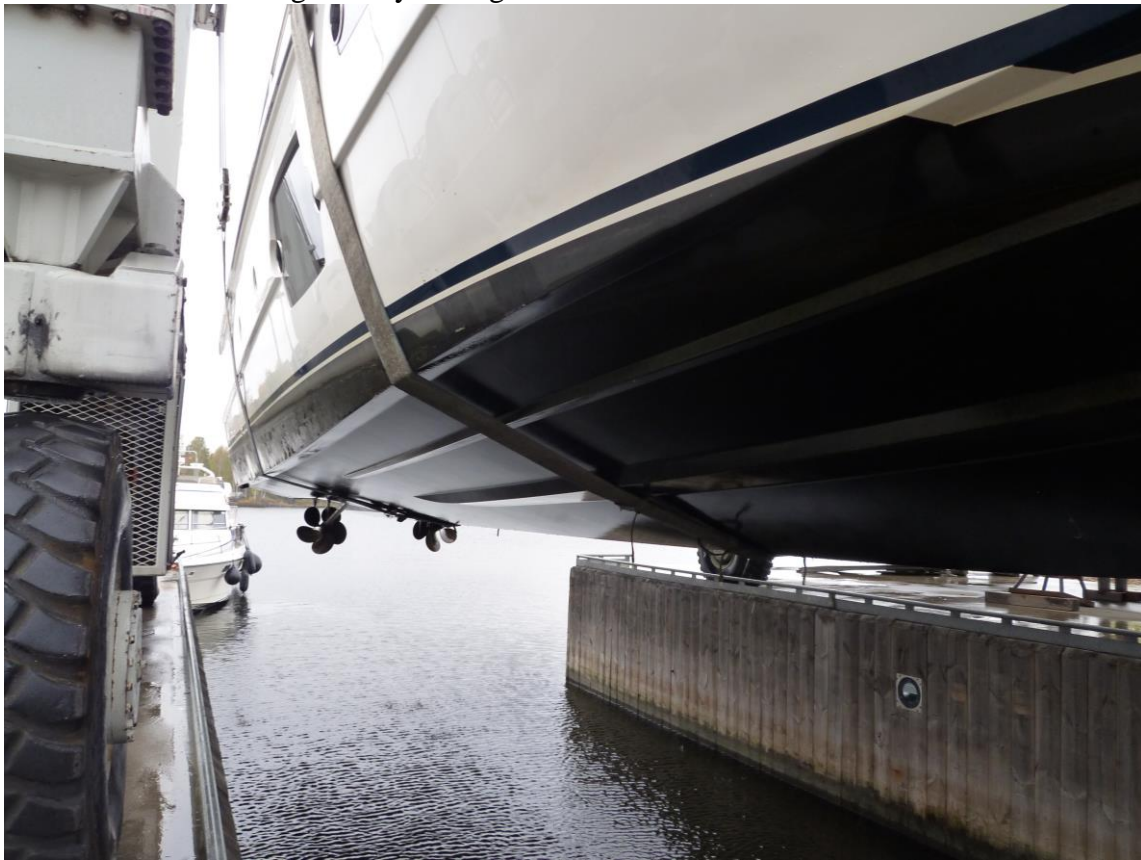
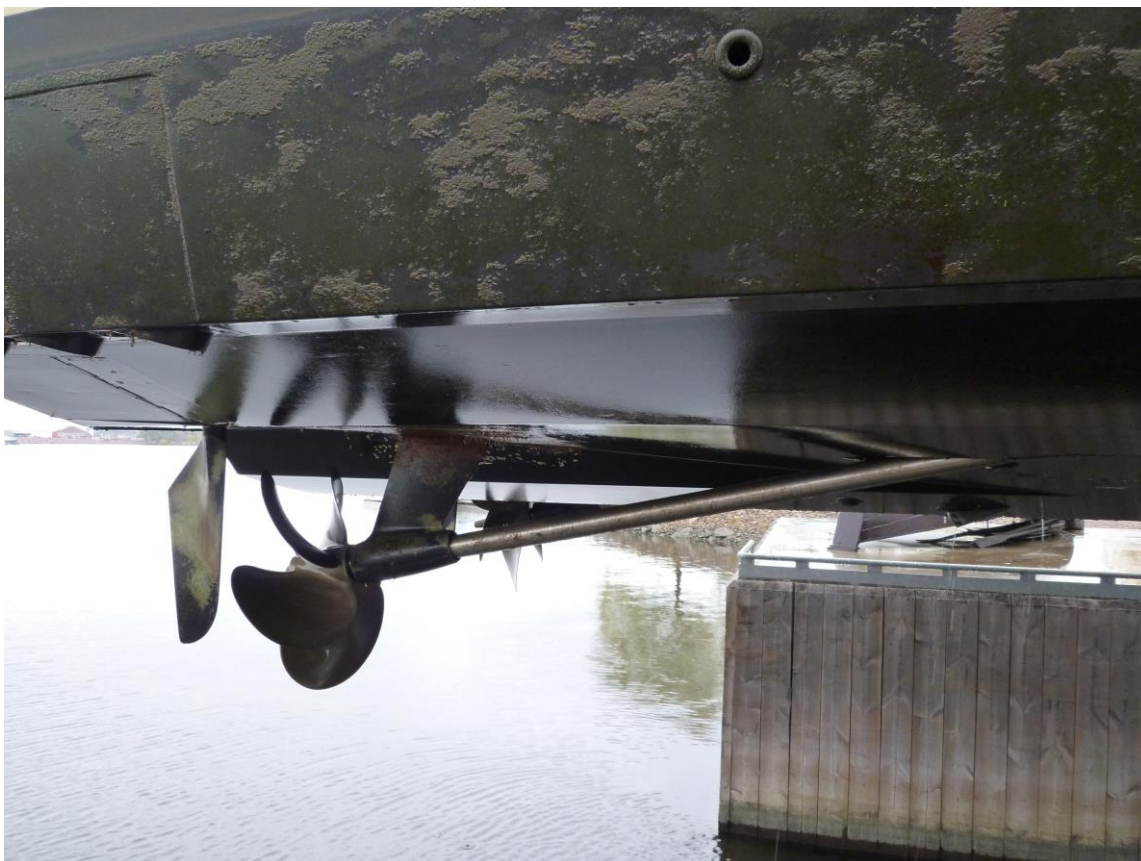
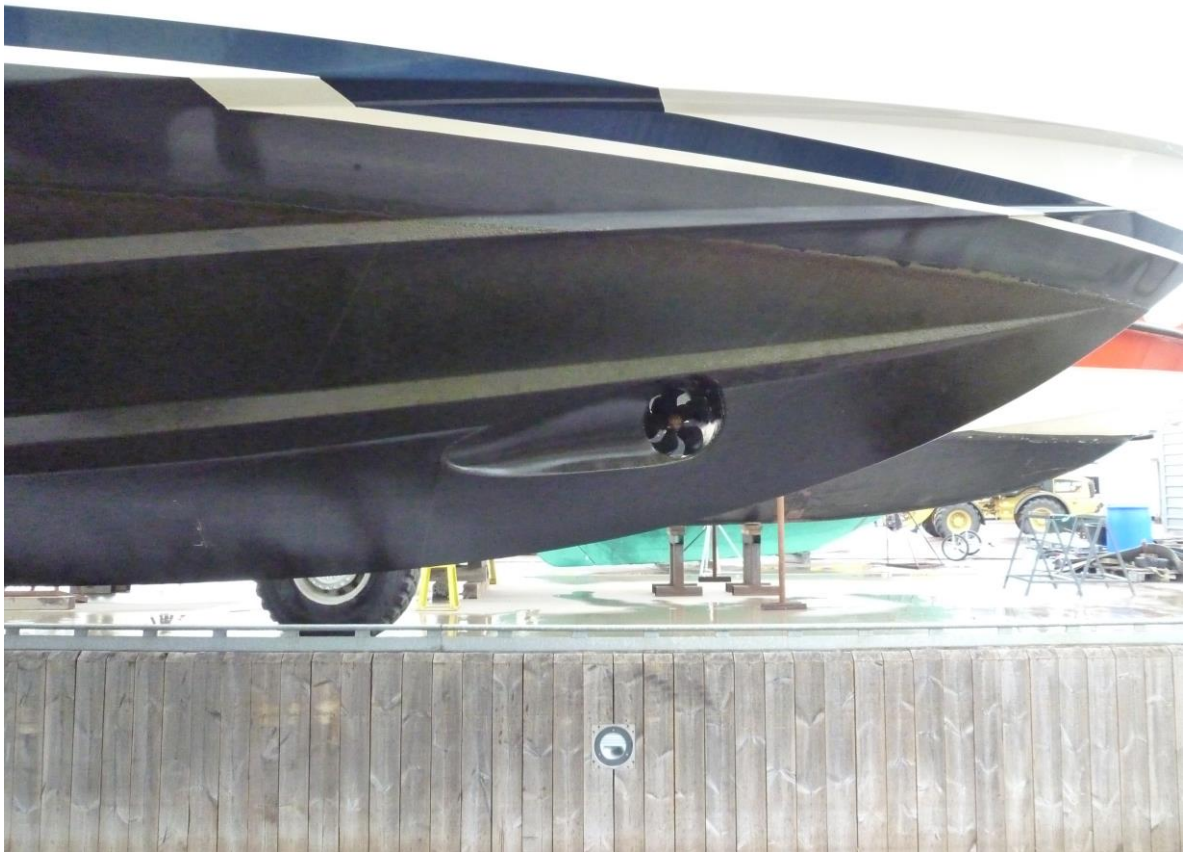
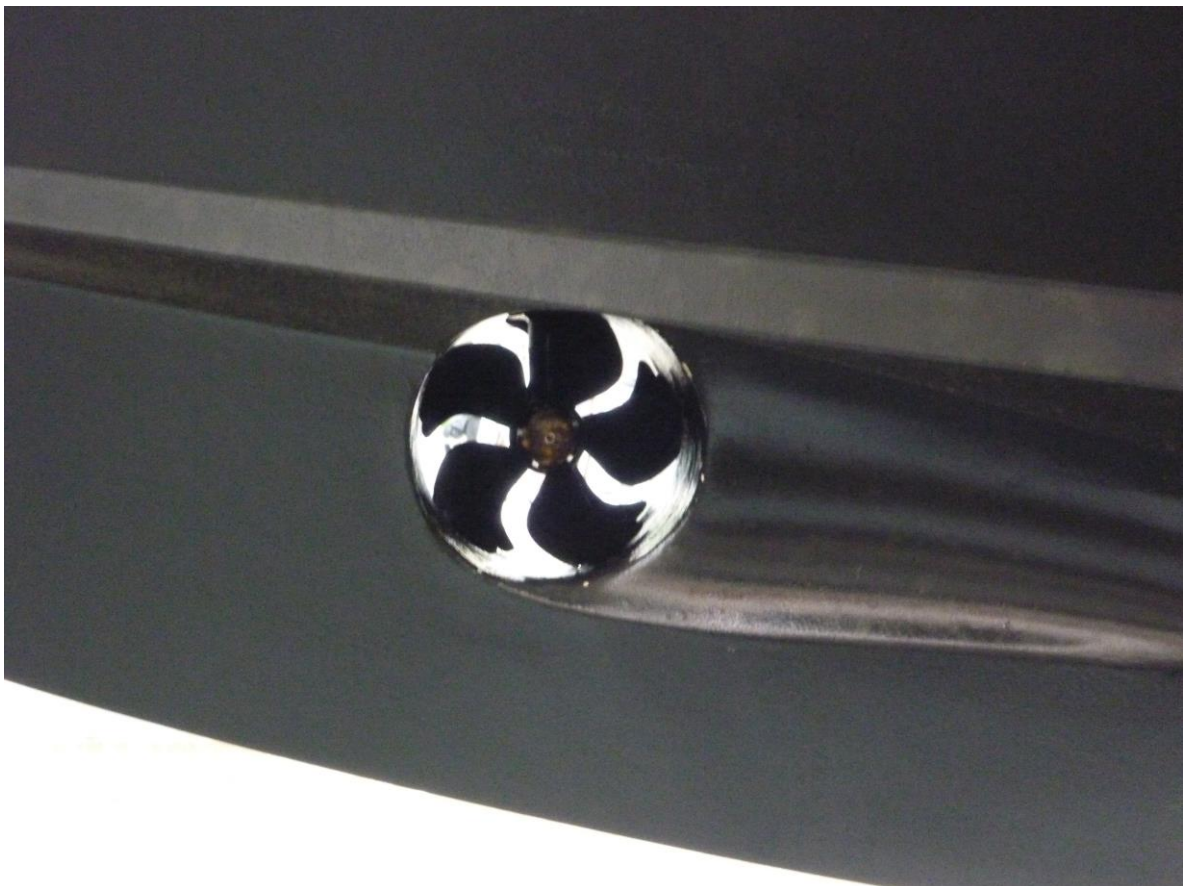
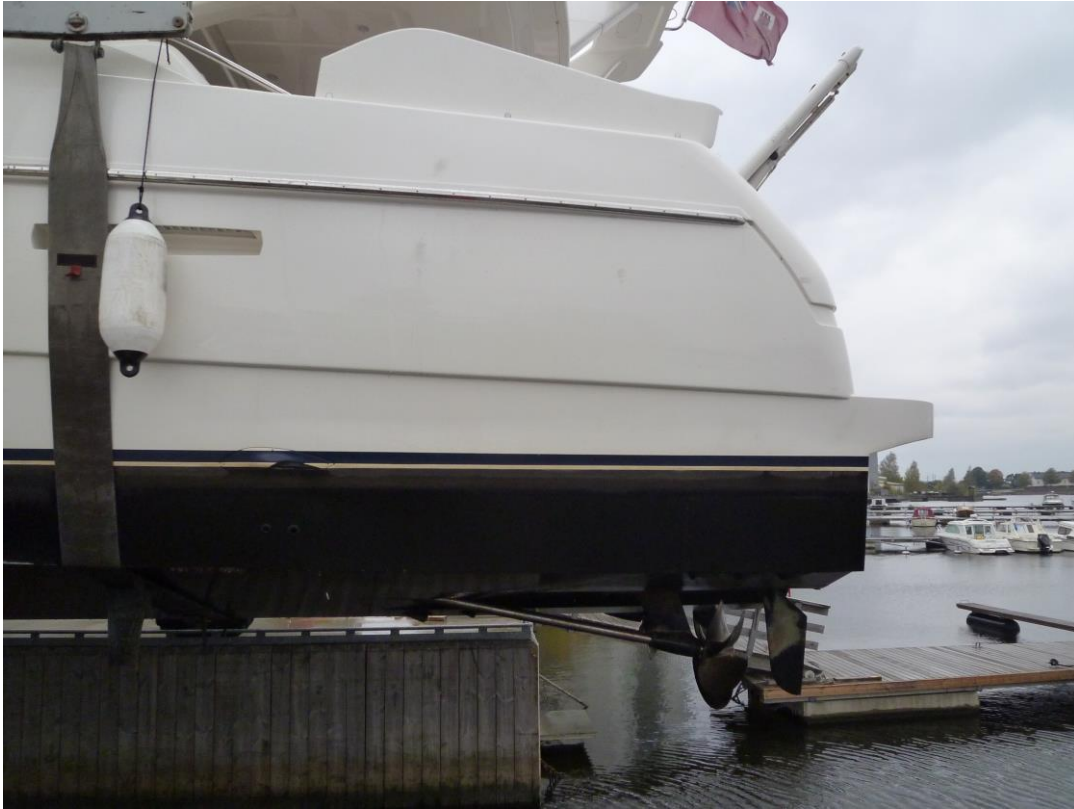
-The bottom seems to generally be in good condition

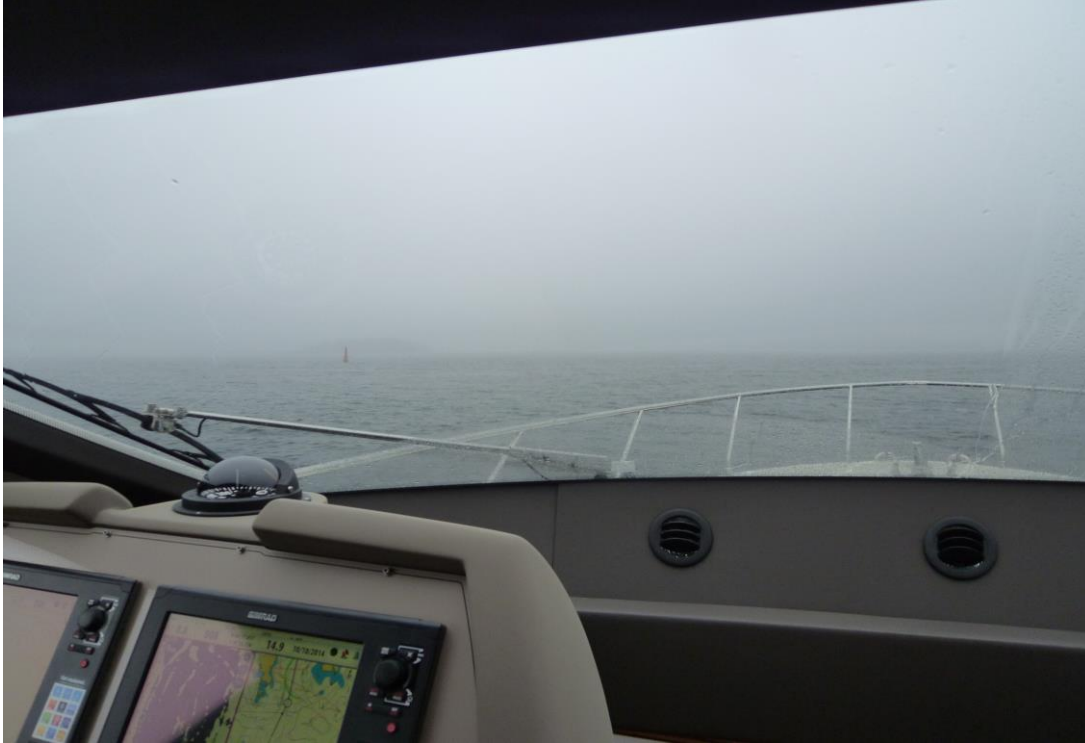
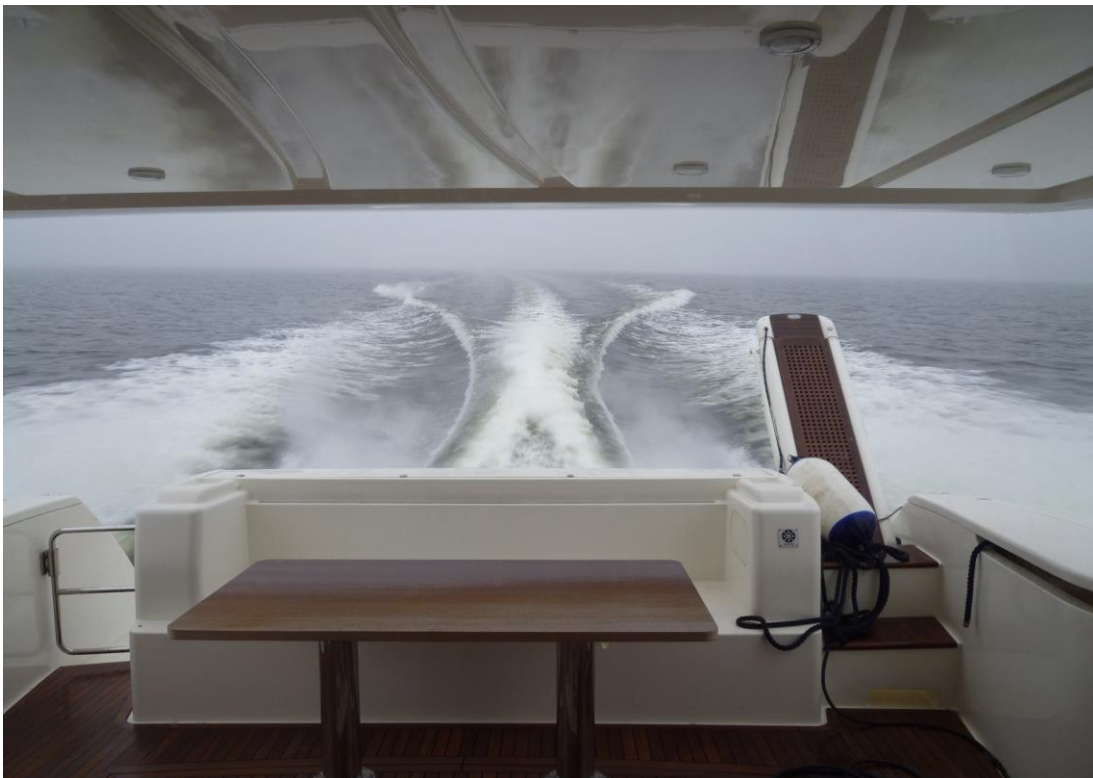
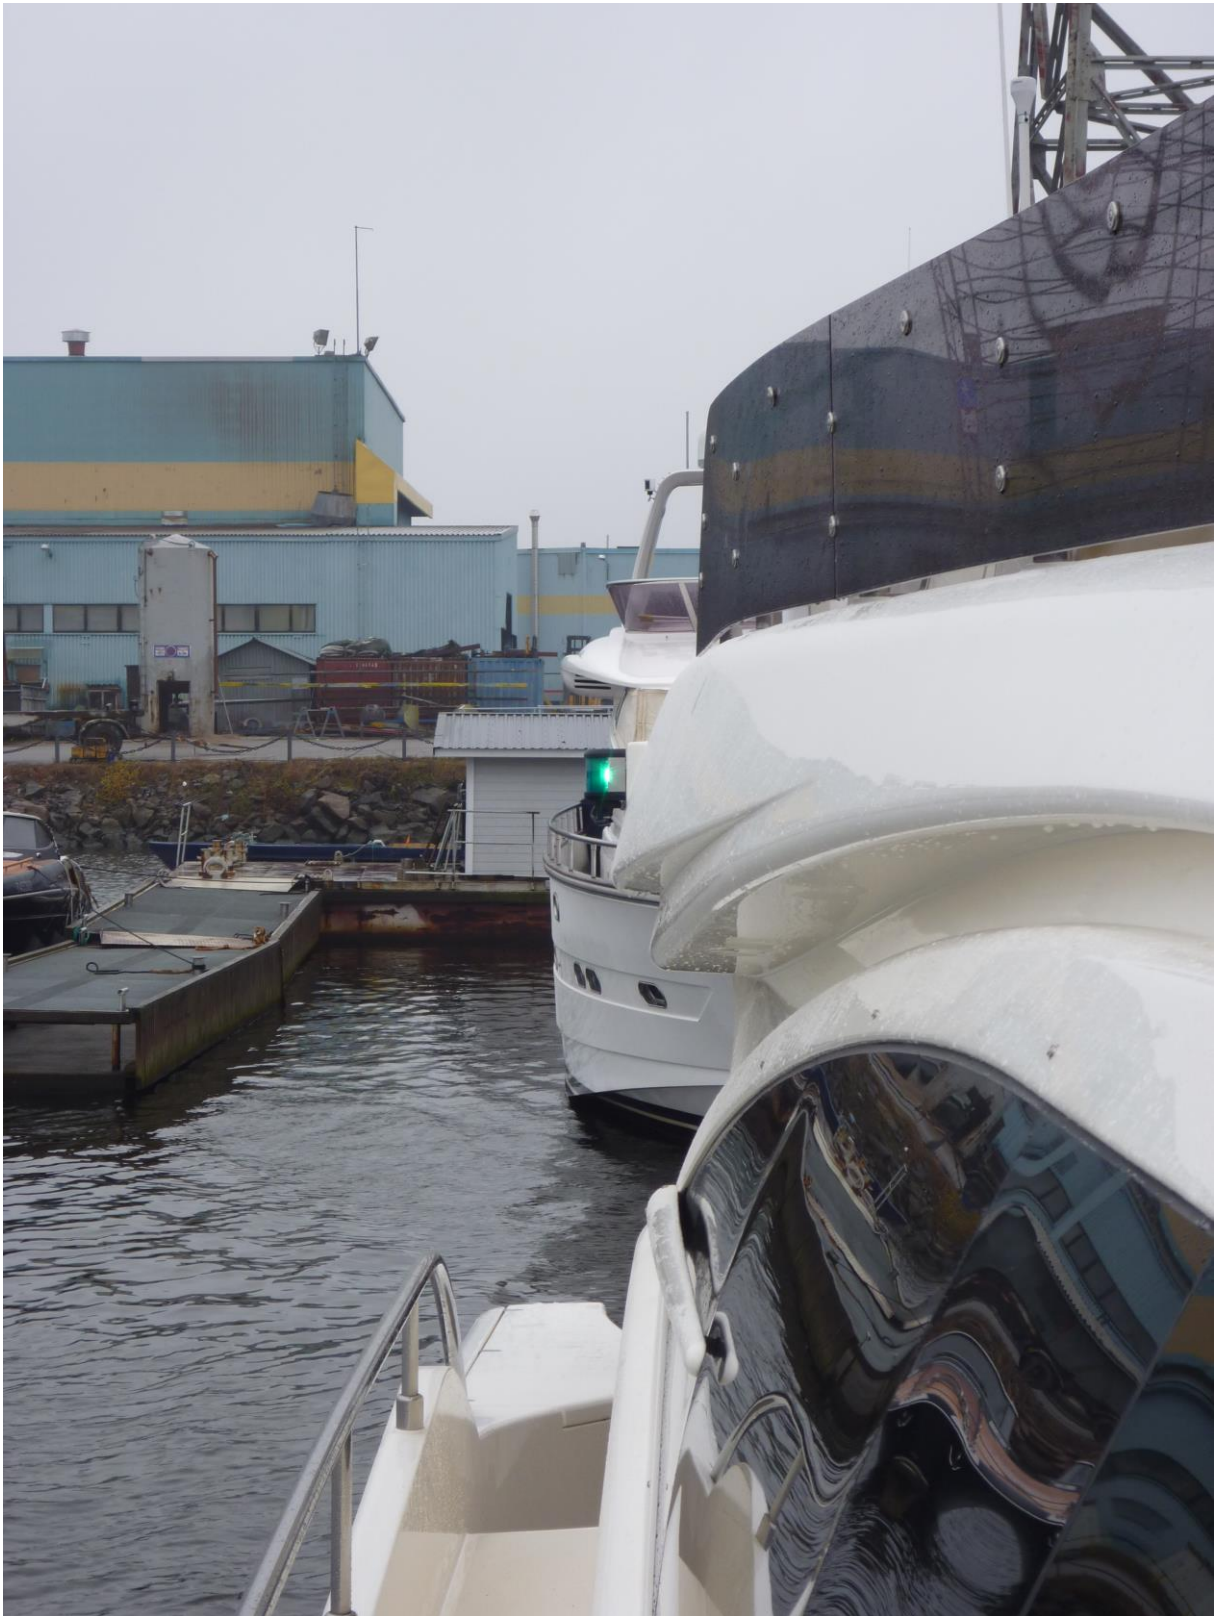
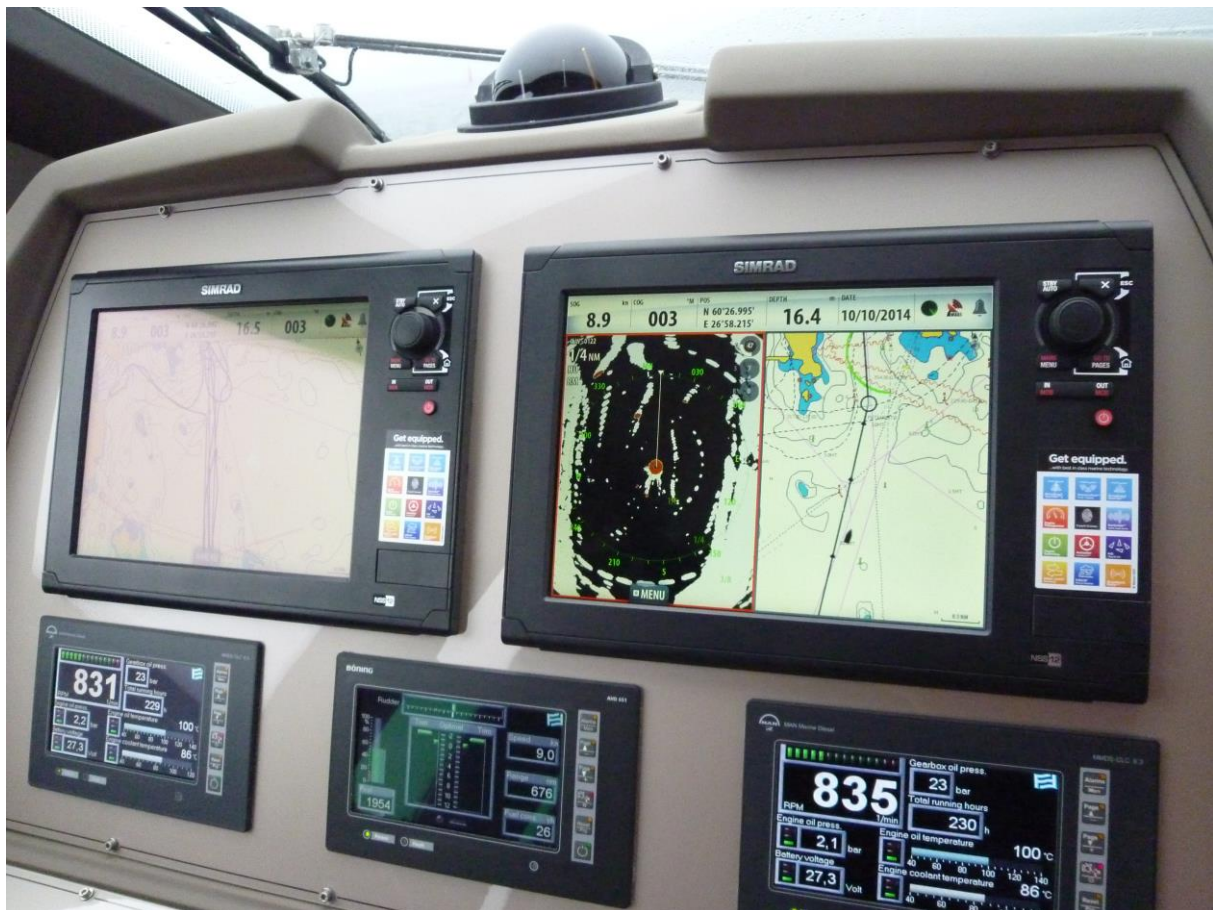
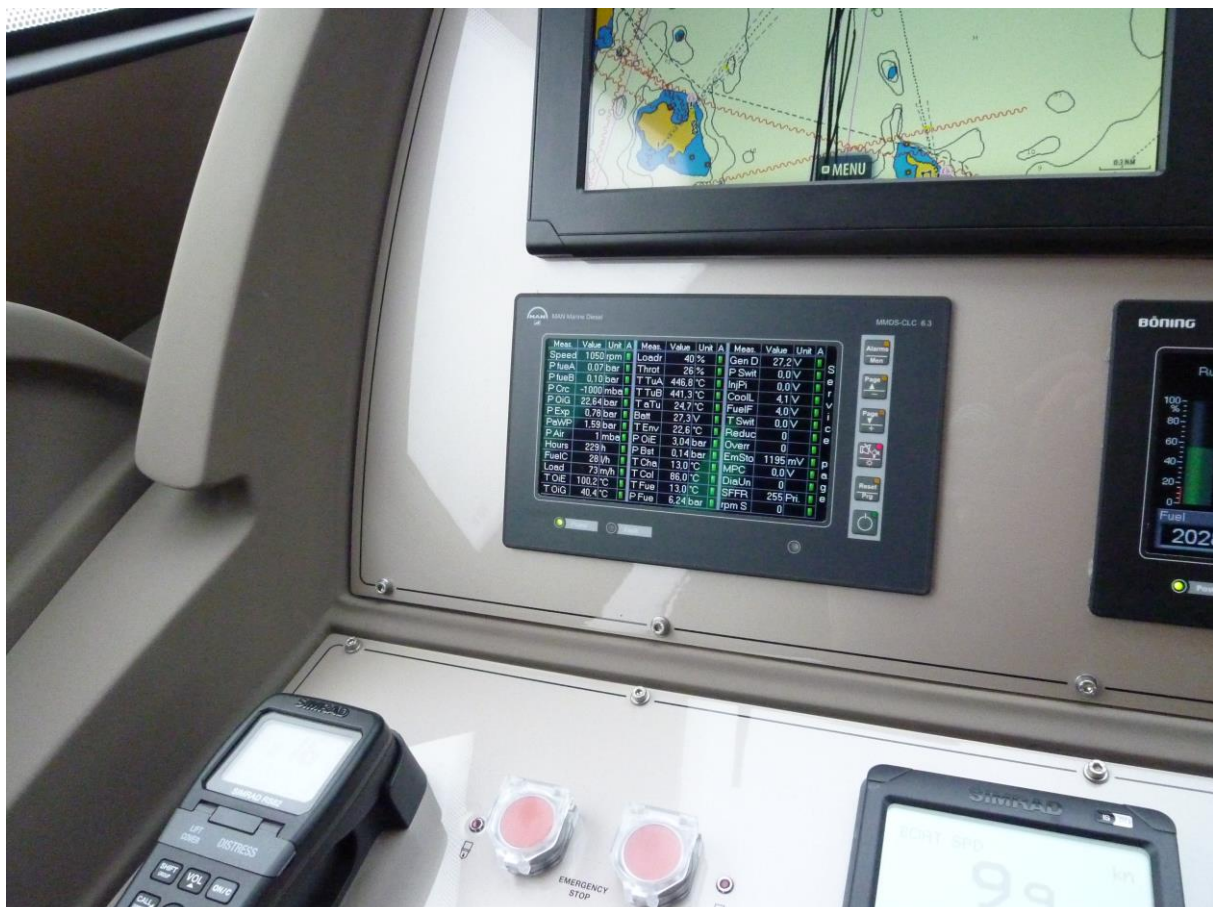
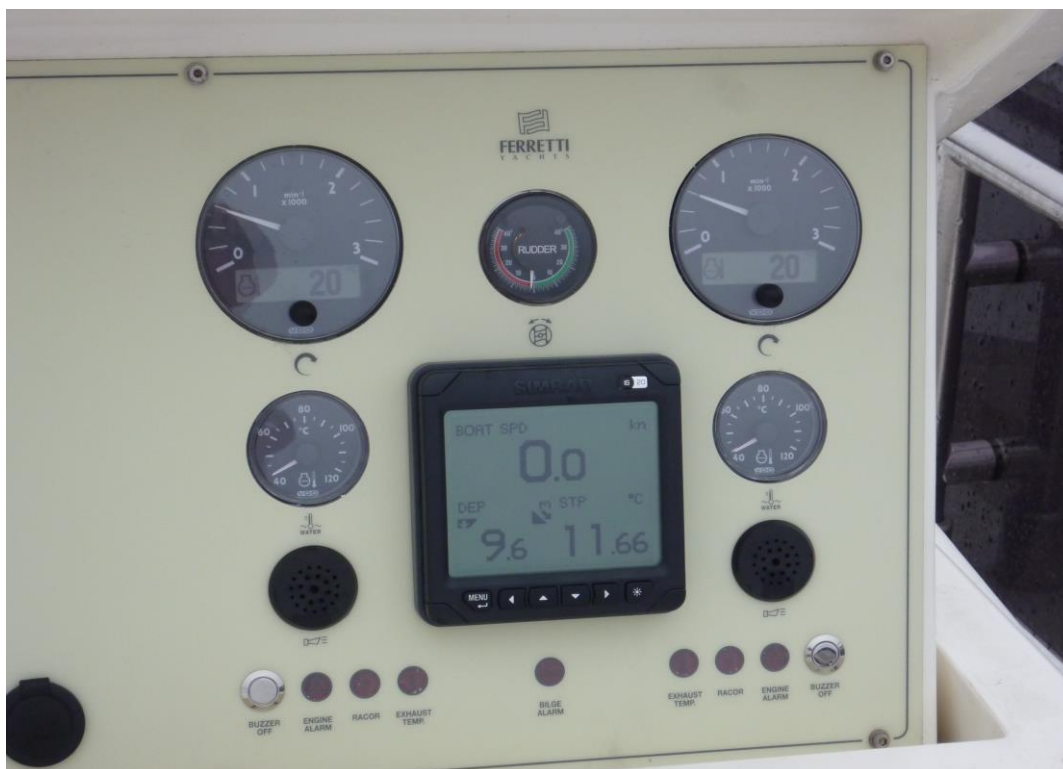
-The sea trial went well, and everything was normal, except for a slight vibration at full speed. At cruising speed no vibrations could be felt. The vibration may be caused by the damaged propeller and/or a slightly bent, or out of line, propeller shaft.

- The hull damage under the SB engine must be repaired, together with the oil and water leakage. If the engine must be removed it can be an expensive repair.
- The BB propeller must be repaired or replaced.
- The BB propeller shaft support must be checked and/or repaired.
- Both propeller shafts should be measured that they are straight and in line. If that is not the case, they should be repaired or replaced.
